# Hydrology, Water Chemistry, and Vegetation Characteristics of a Tamarack Bog in Bath Township, Ohio: Towards Restoration and Enhancement<sup>1</sup>

OHIO J SCI 105 (2):21-30, 2005

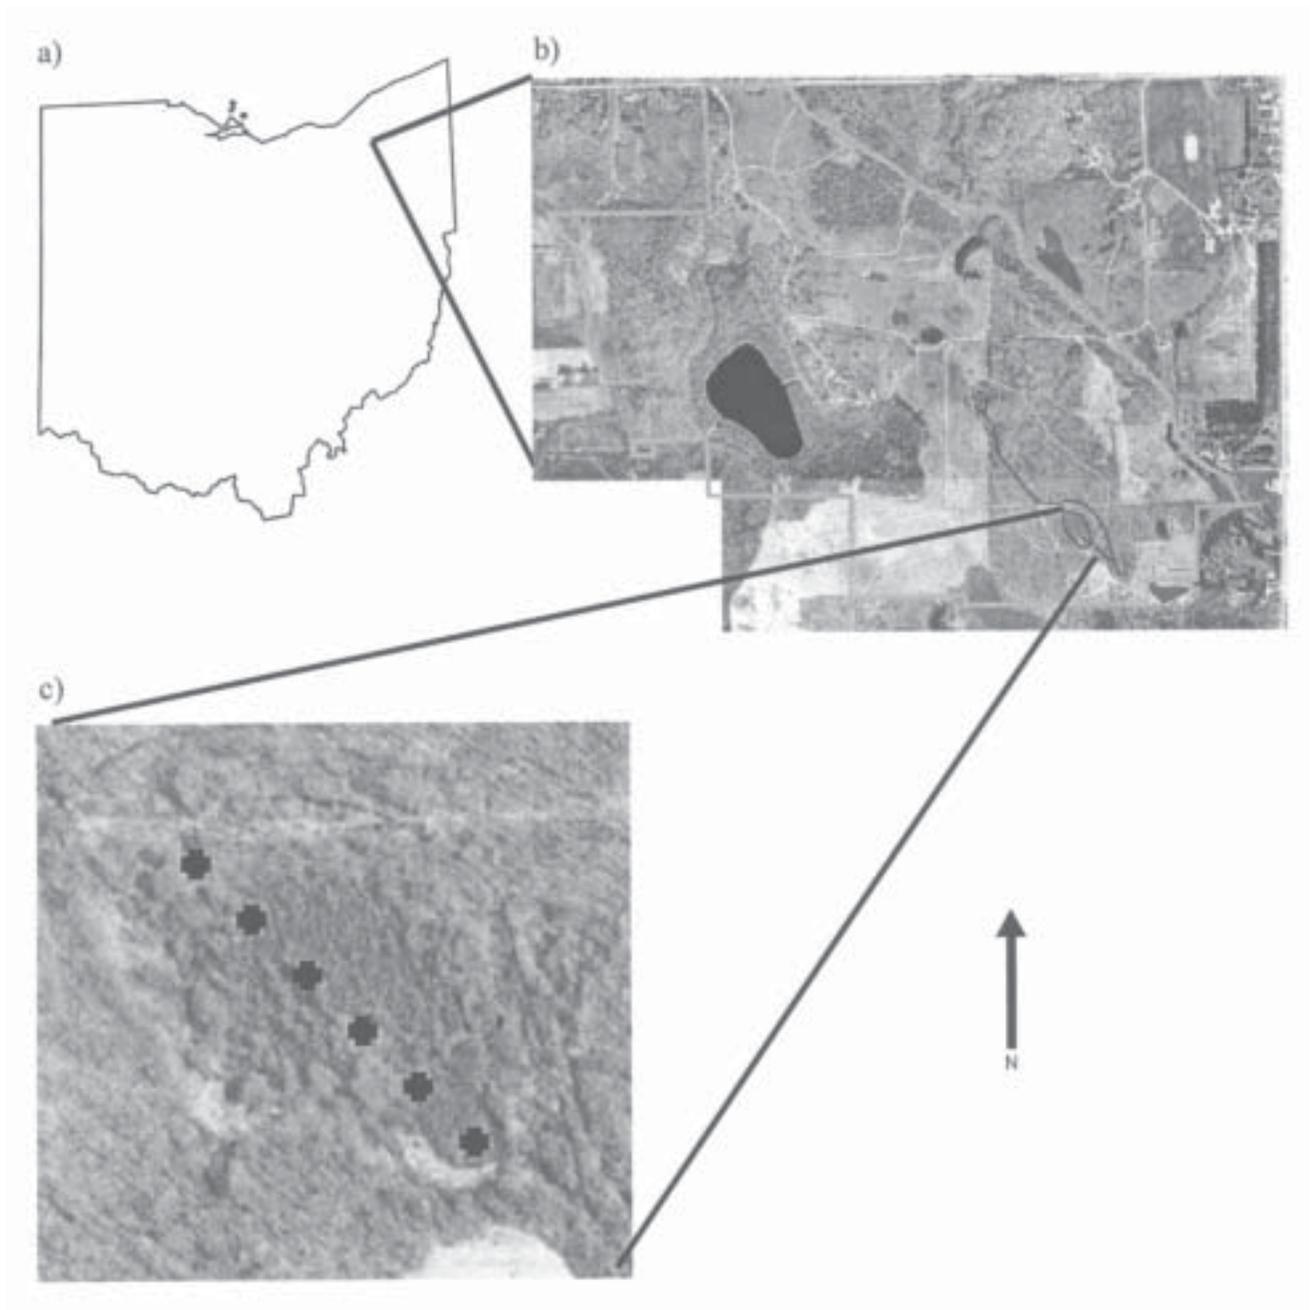
FIGURE 1. Location map of study site; where a) is Ohio, b) is the Bath Nature Preserve, and c) is the Tamarack Bog. The crosses in the Tamarack Bog represent the transect of water level wells located in the bog.

Bath Nature Preserve (BNP) is a 404-acre (163.62 ha) parcel located in the glaciated plateau of northeastern Ohio (Fig. 1a). The property (formerly part of tire manufacturer Raymond Firestone's country estate) is now owned by Bath Township, and preserves healthy examples of habitats such as open grasslands, mature mixed deciduous forests, wetlands, streams, and ponds. Notably, the preserve includes a tamarack bog, located

in the southeast section (Fig. 1b).

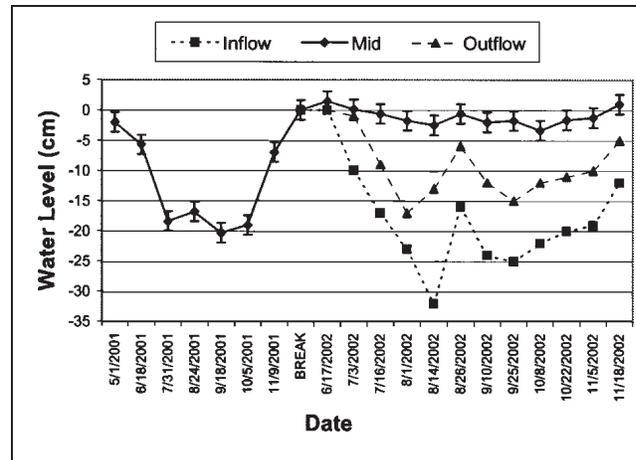
FIGURE 2. Water levels of the Bath Tamarack Bog. There is a break in the data between 9 November 2001 and 17 June 2002. The term "BREAK" on the x-axis refers to the break in data collection with respect to the middle of the bog. Error bars represent +1 standard error.

The hydrology of the bog center demonstrated more variance in the 2001 season than the 2002 season (Fig. 2). In 2001, the water levels of the middle fluctuated from a high of  $-2.0$  cm to a low of  $-20.0$  cm. In 2002, the

hydrology of the bog was more stable, ranging from  $+2.0$  cm to  $-3.0$  cm. The inflow and outflow both demonstrated high variance with the inflow being more severe. Inflow water levels ranged from  $0.0$  cm to  $-32.0$  cm, while outflow levels ranged from  $0.0$  cm to  $-17.0$  cm.

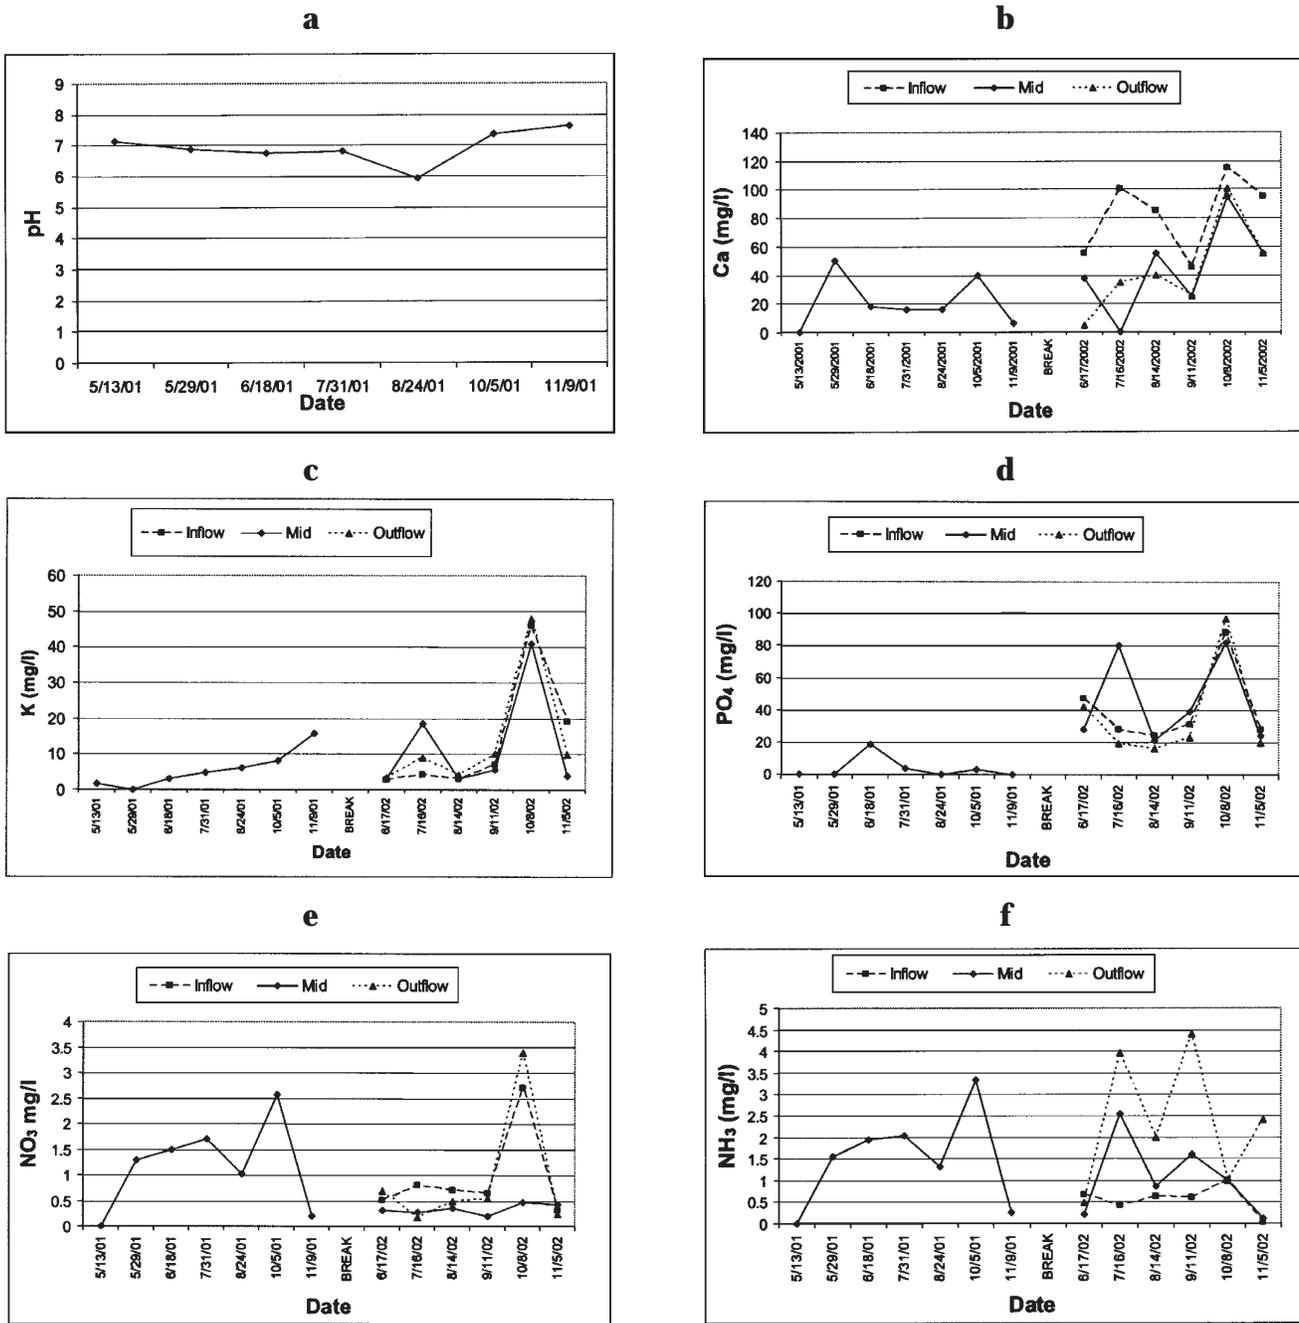
FIGURE 3. Water chemistry measurements; where a) is pH levels from the center of the Bath Tamarack Bog, b) is calcium levels, c) is potassium levels, d) is phosphate levels, e) is nitrate levels of the Bath Tamarack Bog, and f) is ammonia levels of the Bath Tamarack Bog. There is a break in the data between 9 November 2001 and 17 June 2002. The term "BREAK" on the x-axis refers to the break in data collection with respect to the middle of the bog.

The pH, calcium, potassium, phosphate, nitrate, and ammonia levels for 2001 and 2002 are detailed in Figure 3 (a–f). pH (Fig. 3a) shows little variation between May and November of 2001, but quite high values from 6.0 to 7.7. Calcium (Fig. 3b) tended to increase in the fall. Generally the inflow values were greater than mid- and outflow. Similar to calcium, potassium (Fig. 3c), phosphate (Fig. 3d), nitrate (Fig. 3e), and ammonia (Fig. 3f) had high values in October. The highest ammonia values were detected in the outflow (Fig. 3f).

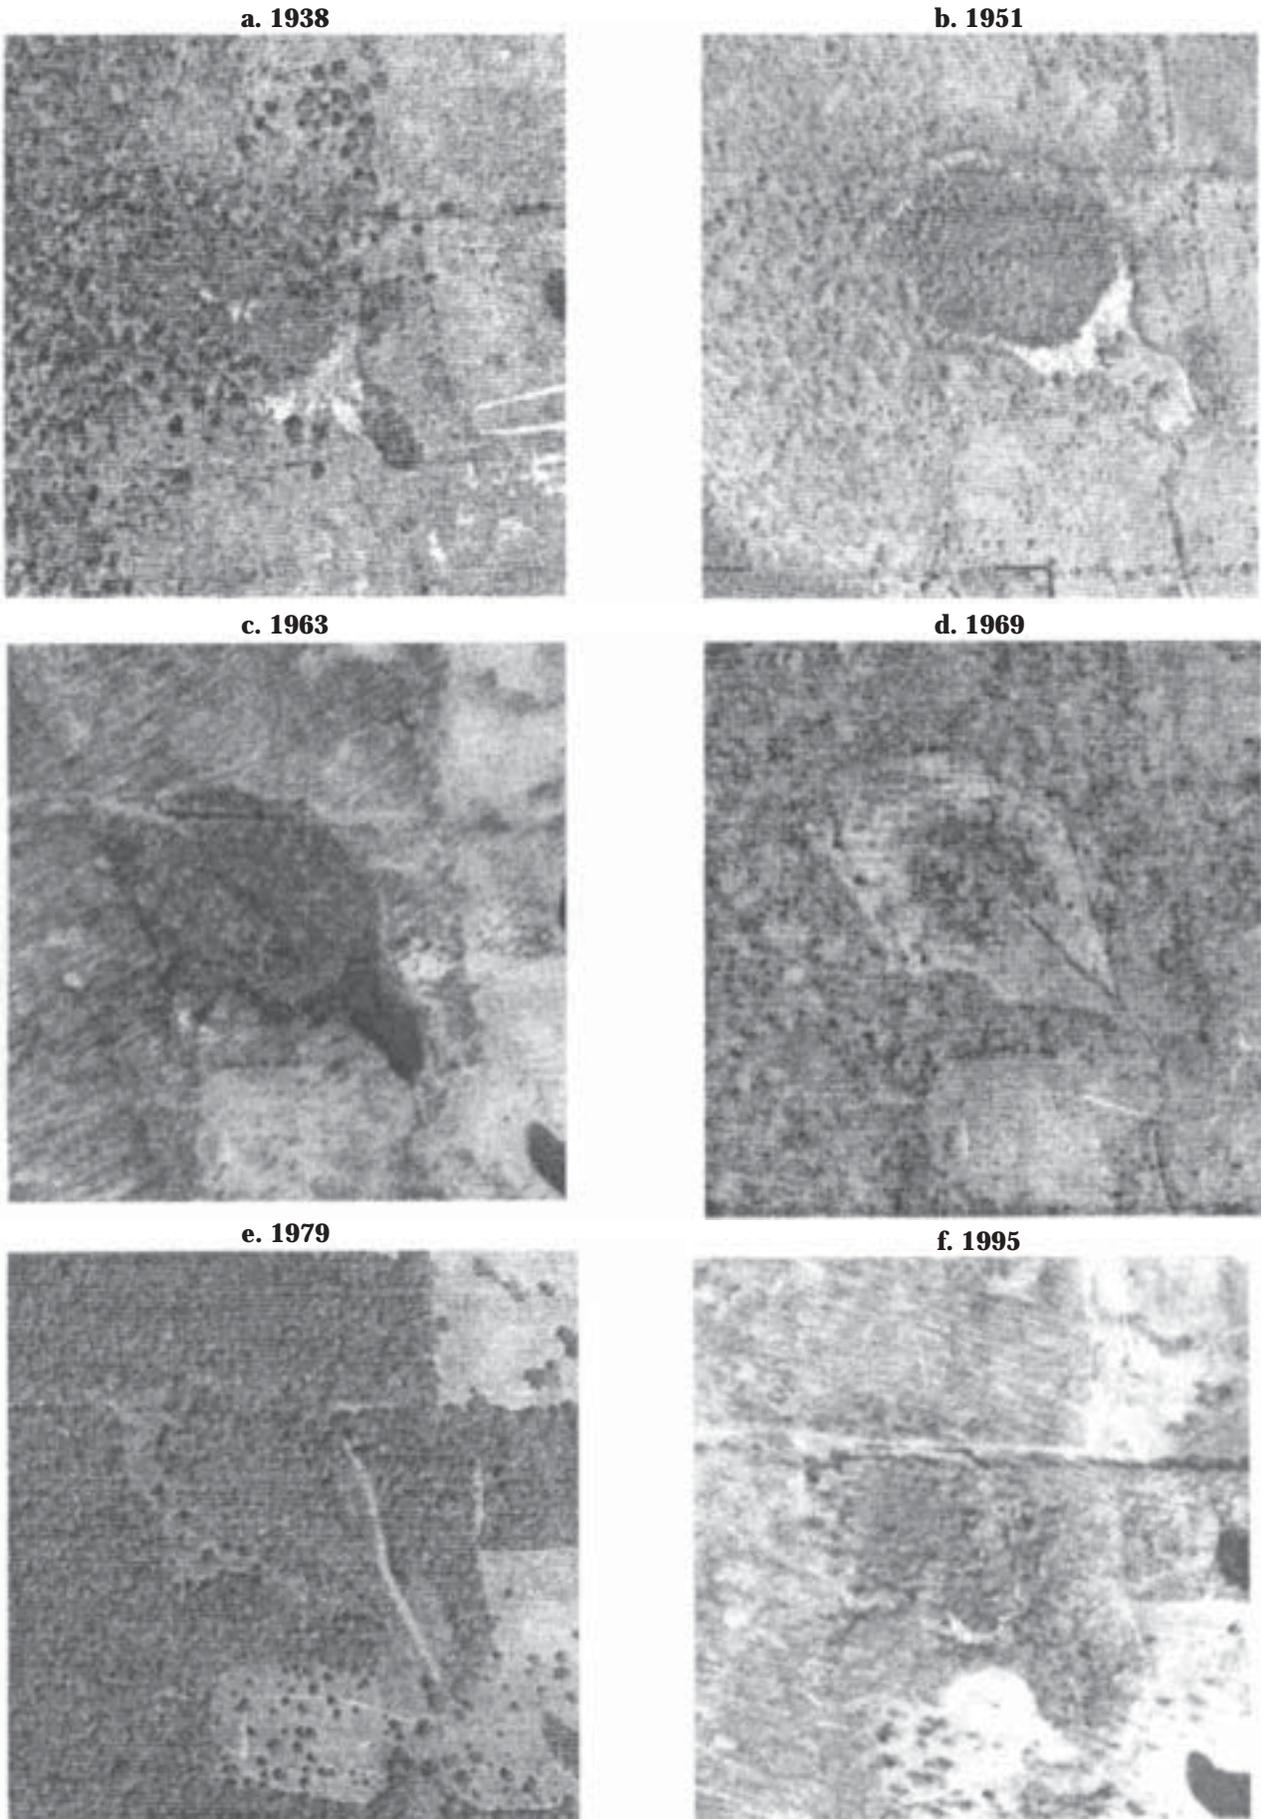
FIGURE 4. Aerial photographs of the Bath Tamarack Bog.

The 1938 aerial photograph of the bog, the oldest available, shows a bog of approximately 5.6 ha and provides evidence for standing water at the southeast end of the bog (Fig. 4a). Standing water is apparent in both the 1951 (Fig. 4b) and 1963 (Fig. 4c) photographs as well. In addition, gas lines appear to have been in-

stalled, crossing through the northern end of the bog in the 1963 photograph. The 1969 aerial photograph (Fig. 4d) shows two ditches present, one through the center of the bog and the other along the east side of the bog. Standing water is not present in this photograph, suggesting that the ditches were constructed between 1963 and 1969. The 1979 aerial photograph (Fig. 4e) shows little change occurring in the area. Lastly, the 1995 (Fig. 4f) photograph is the most recent and is more or less consistent with the current condition of the tamarack bog and surrounding area. The wet area encompassing

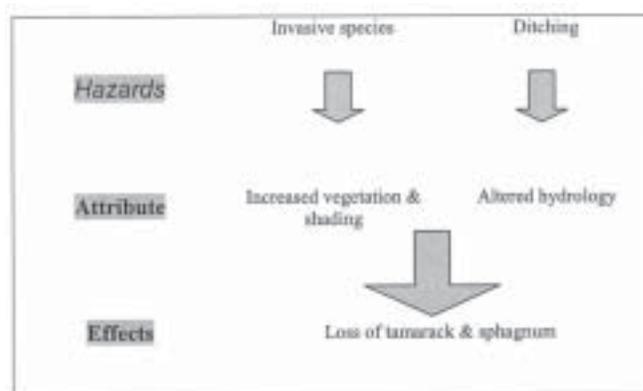
FIGURE 5. Hazards affecting the Bath Tamarack Bog.

Figure 5 shows the effects of the identified hazards on the bog. Invasive species and ditching have both contributed to the loss of tamarack and *Sphagnum* via changes in vegetation and hydrology. The goals of any restoration should be to increase the cover of sphagnum and the number of tamaracks in the bog. Further goals, such as a self-sustaining population of tamaracks may not be practical (NRC 2001).
